**Flood Control Project Maintenance  
Levee Inspections**

**2018 Channel Summary Report**

**Madera County FCWCA**

**Ash Slough**

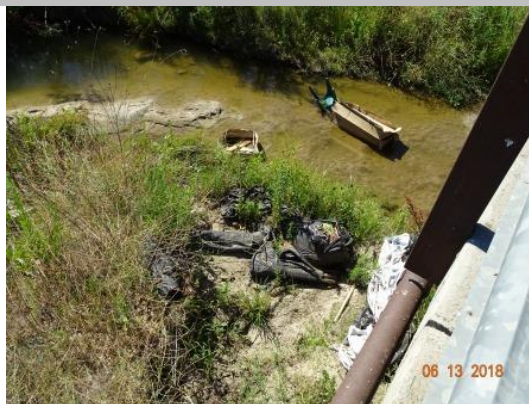
Photo 1 of 2 : CH\_2018\_NA0011\_38\_35\_20180614\_00045.jpg

Inspector Comments: Some trash was found in the channel.

View upstream of trash in the channel. (2018)

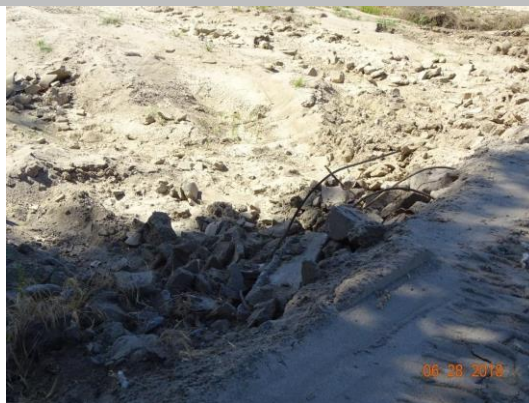
Photo 1 of 1 : CH\_2018\_NA0011\_38\_53\_20180629\_00061.jpg

Rating **	M	Issue No.	53	GPS Lat/Long
Issue Type +	Ma	Location *		37.113239 °
Category	Rivers, Channels & Designated Flood			-120.329124 °
Item	Revetments			
DWR ID	DWR_NA0011_38_c_2012_53			
Action/Comments				
Inspector Comments: Revetment on downstream end of low water crossing is scattered and missing in some place.

View of riprap on downstream side of low water channel. Riprap is scattered and missing in some places (2018).

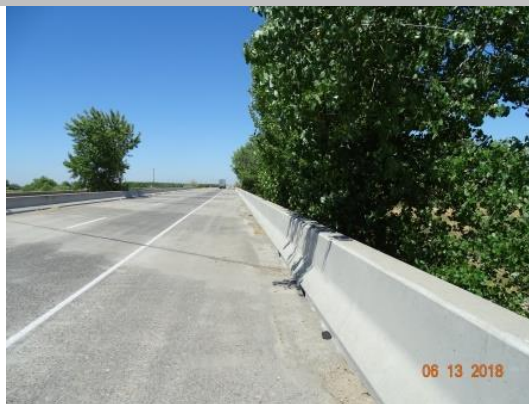
Photo 2 of 6 : CH\_2018\_NA0011\_38\_71\_20180614\_00053.jpg

View of grown trees right next to bridge. (2018)

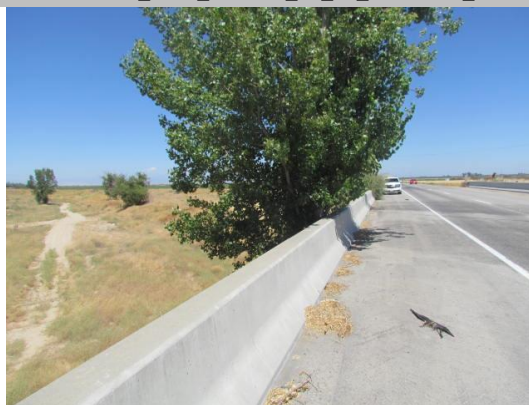
Photo 6 of 6 : CH\_2018\_NA0011\_38\_71\_20180529\_00025.jpg

Looking southeast at trees near bridge. (2016)

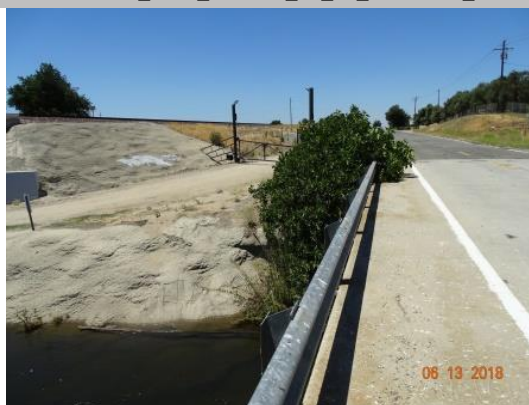
Photo 1 of 5 : CH\_2018\_NA0011\_39\_10\_20180615\_00054.jpg

Fig tree and gate on the downstream right bank. (2018)

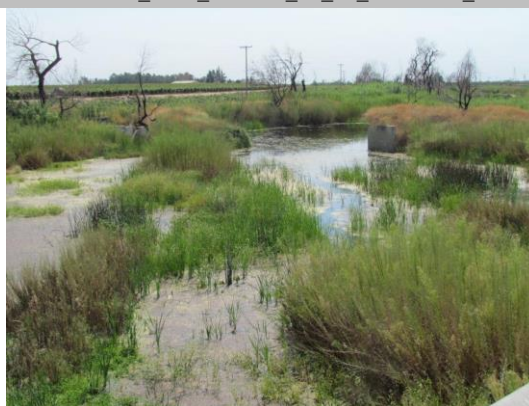
Photo 3 of 3 : CH\_2018\_NA0011\_39\_16\_20180601\_00011.jpg

Looking downstream from Avenue 26 bridge crossing, vegetation in channel needs to be controlled.

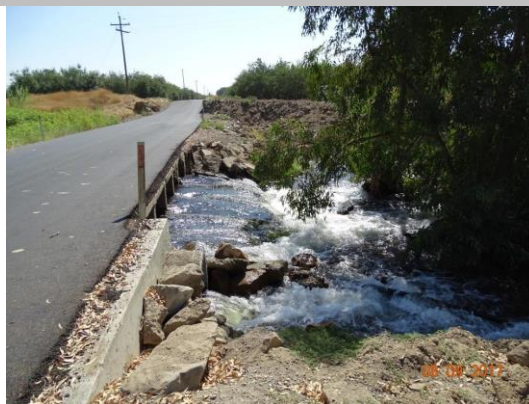
Photo 2 of 2 : CH\_2018\_NA0011\_39\_69\_20180601\_00031.jpg

View of the newly placed riprap on the downstream of the channel.  
Summer 2017

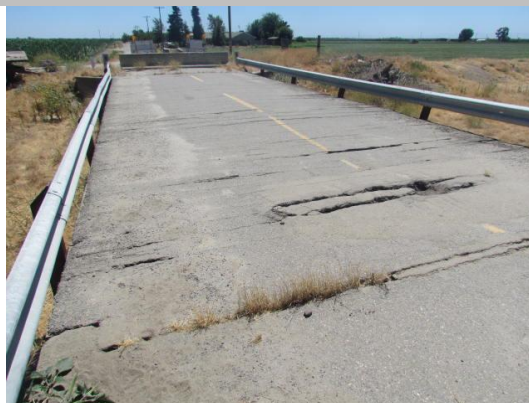
Photo 1 of 1 : CH\_2018\_NA0011\_40\_47\_20180601\_00068.jpg

Looking south at cracks on bridge. (2016)
